# Allied-Axis

THE PHOTO JOURNAL OF THE SECOND WORLD WAR

## Karl-Gerät 040 at the front

Panzerjäger I • SdKfz. 10 1-ton halftrack  
U.S. M2 Treadway Bridge • PzKpfw. IV Ausf. A  
Type 97 Japanese medium tank

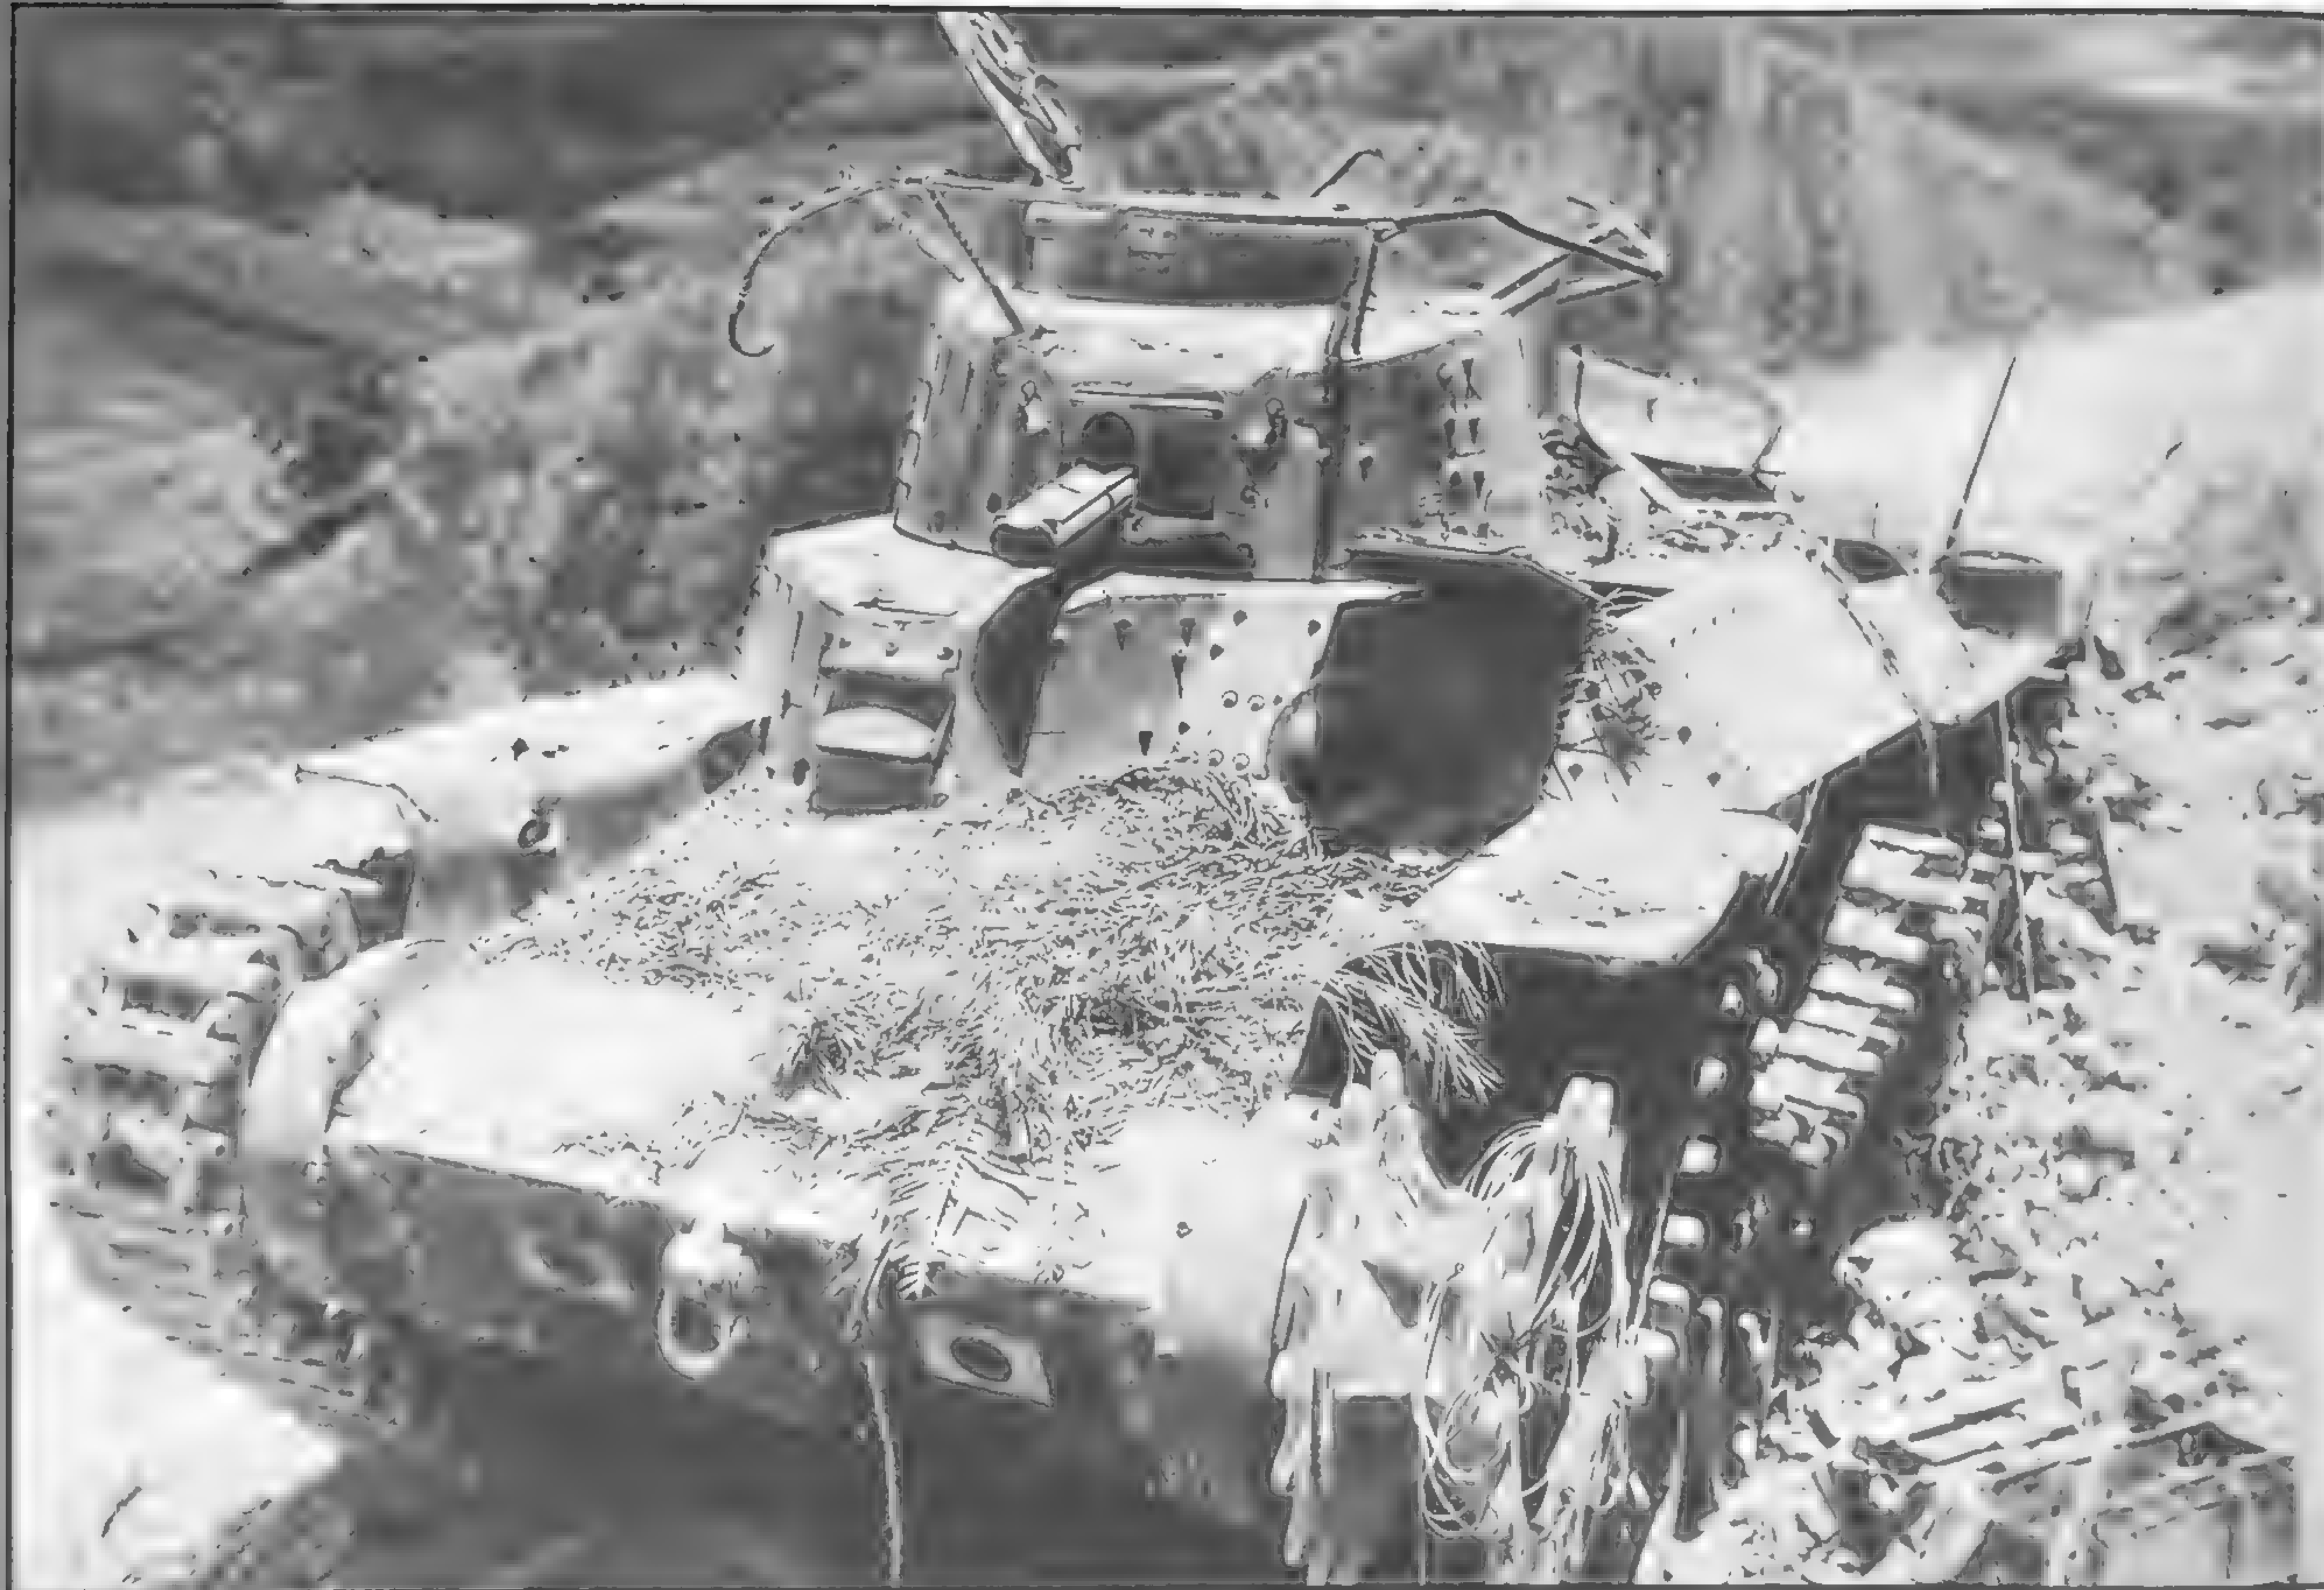
The suspension is the most interesting feature of the Type 97. There are two sets of bogies sprung horizontally, while the two outside wheels were sprung diagonally outwards. It weighed in around 14.3 tons and the engine was an AV-12 air-cooled diesel with 170 hp and a top speed of 23.5 mph. The Japanese never put any emphasis on tank production because of the priority given to ships and planes.

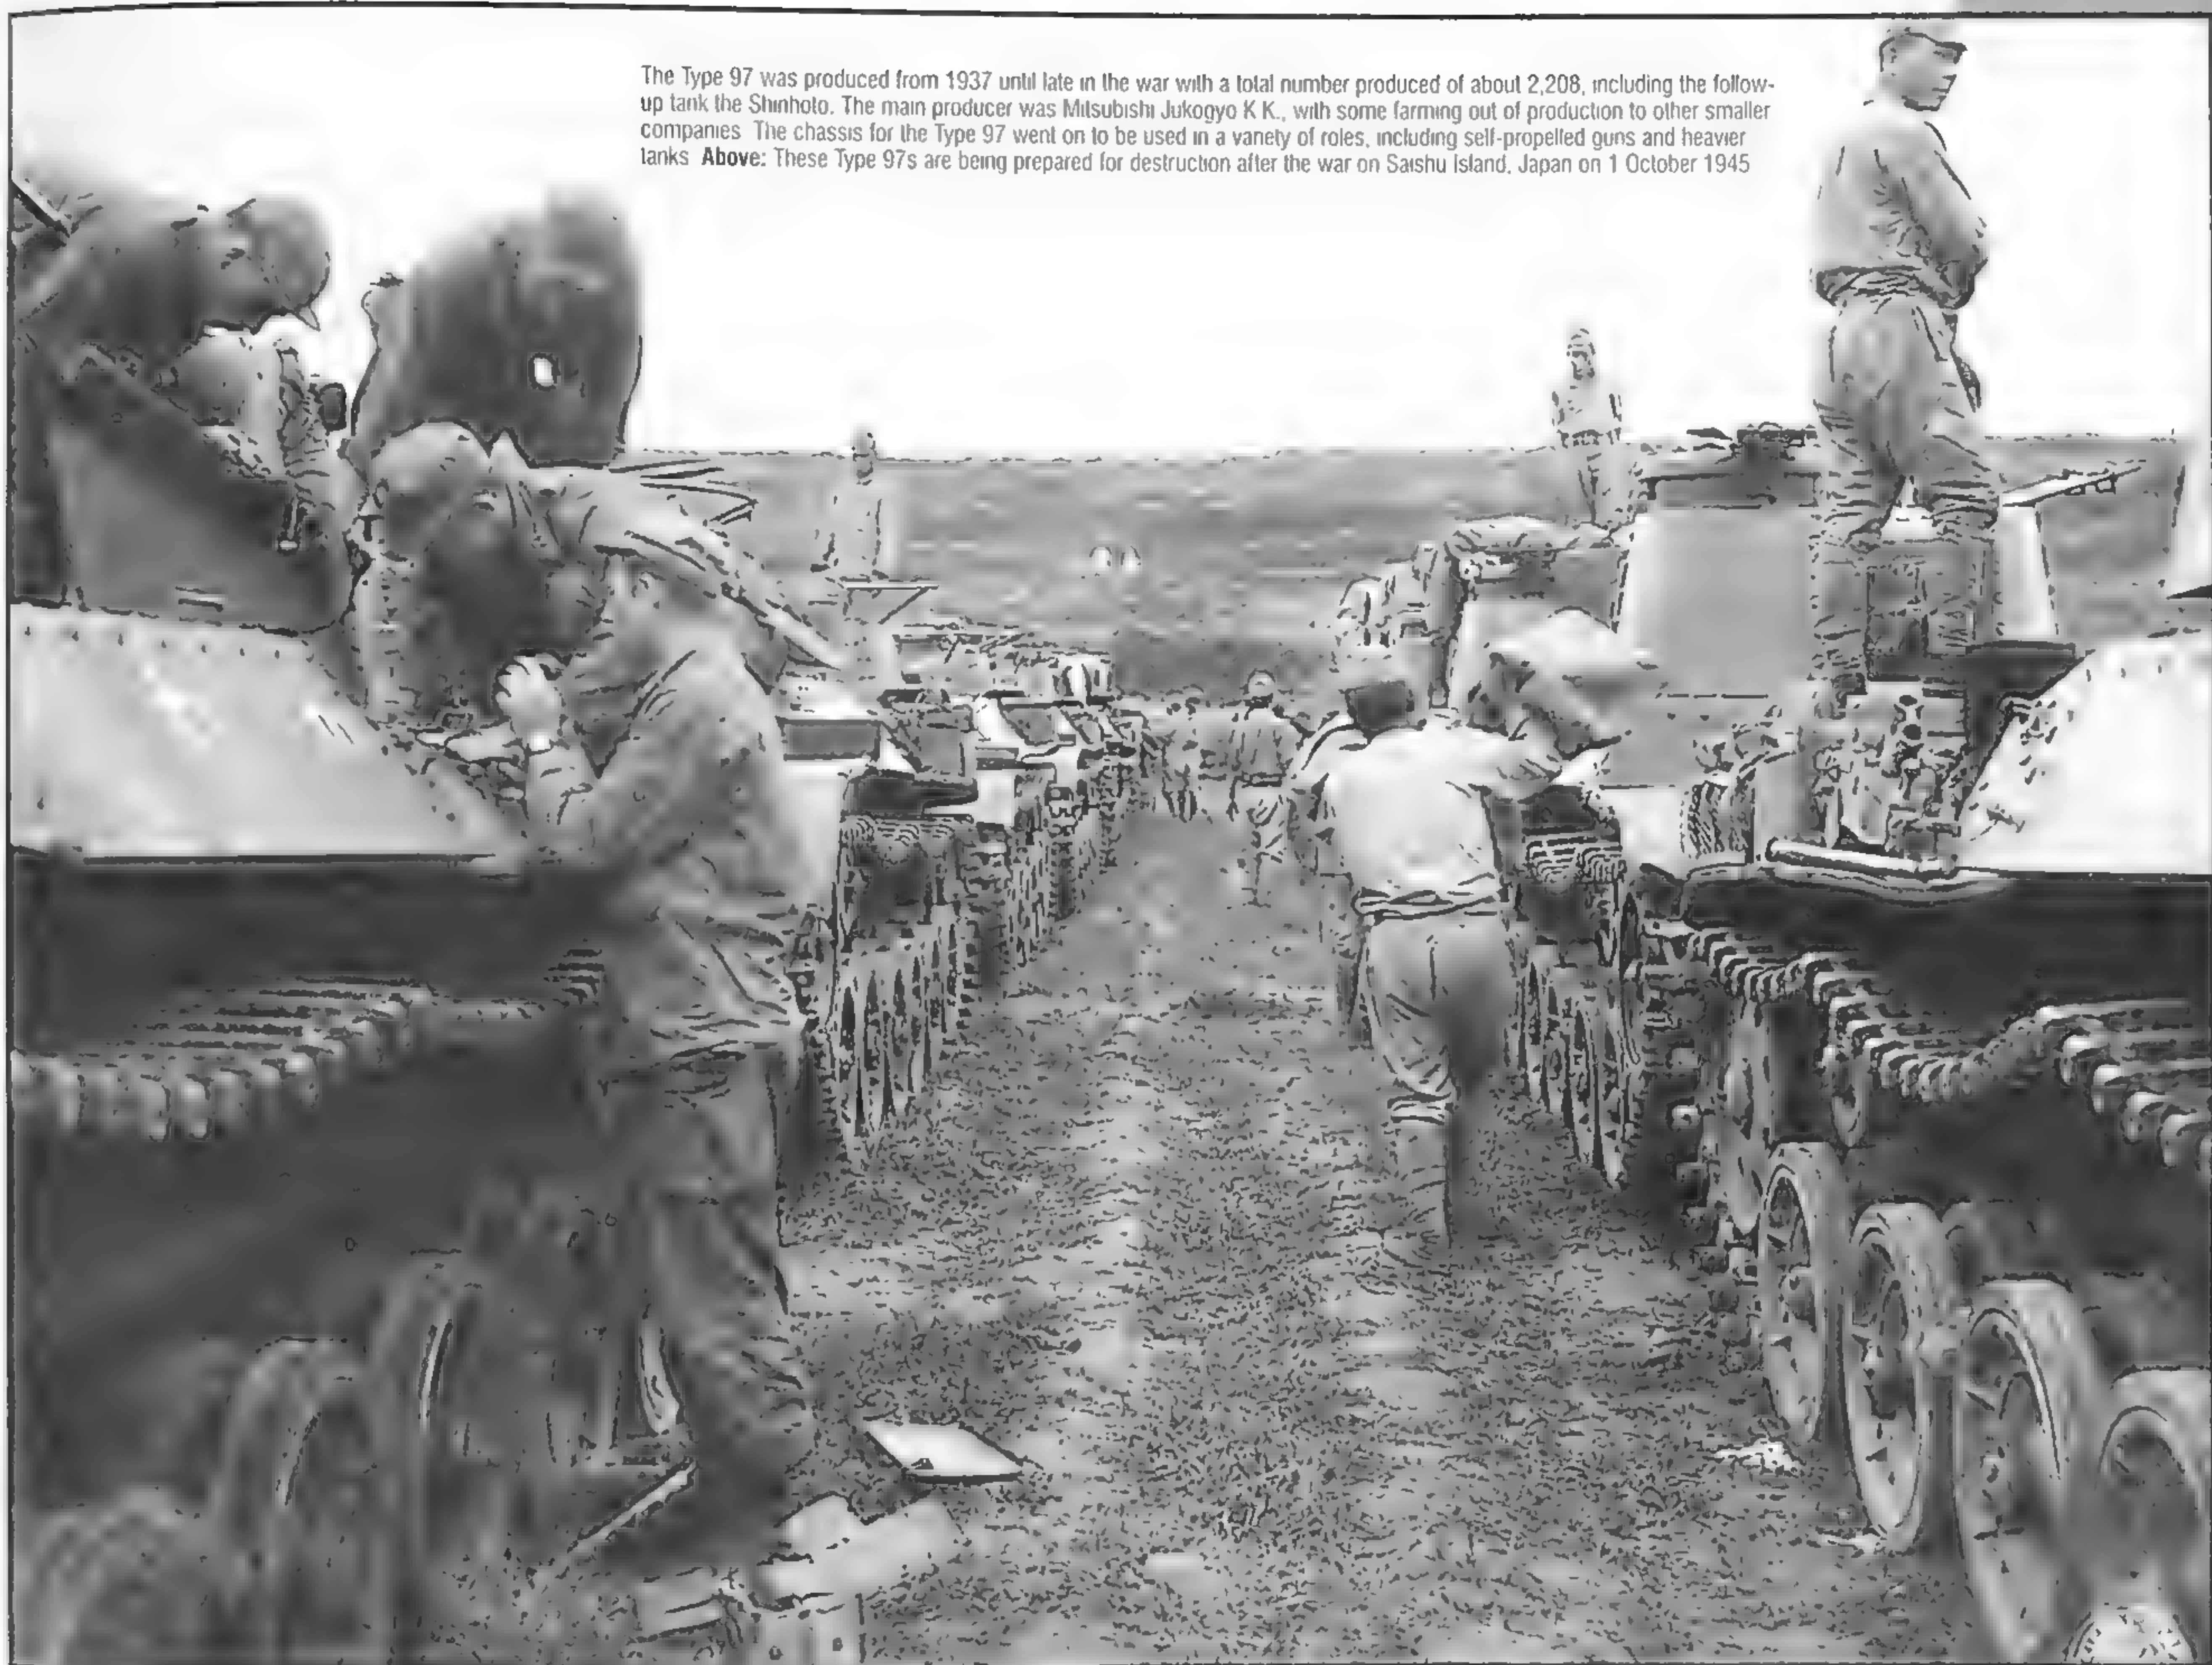
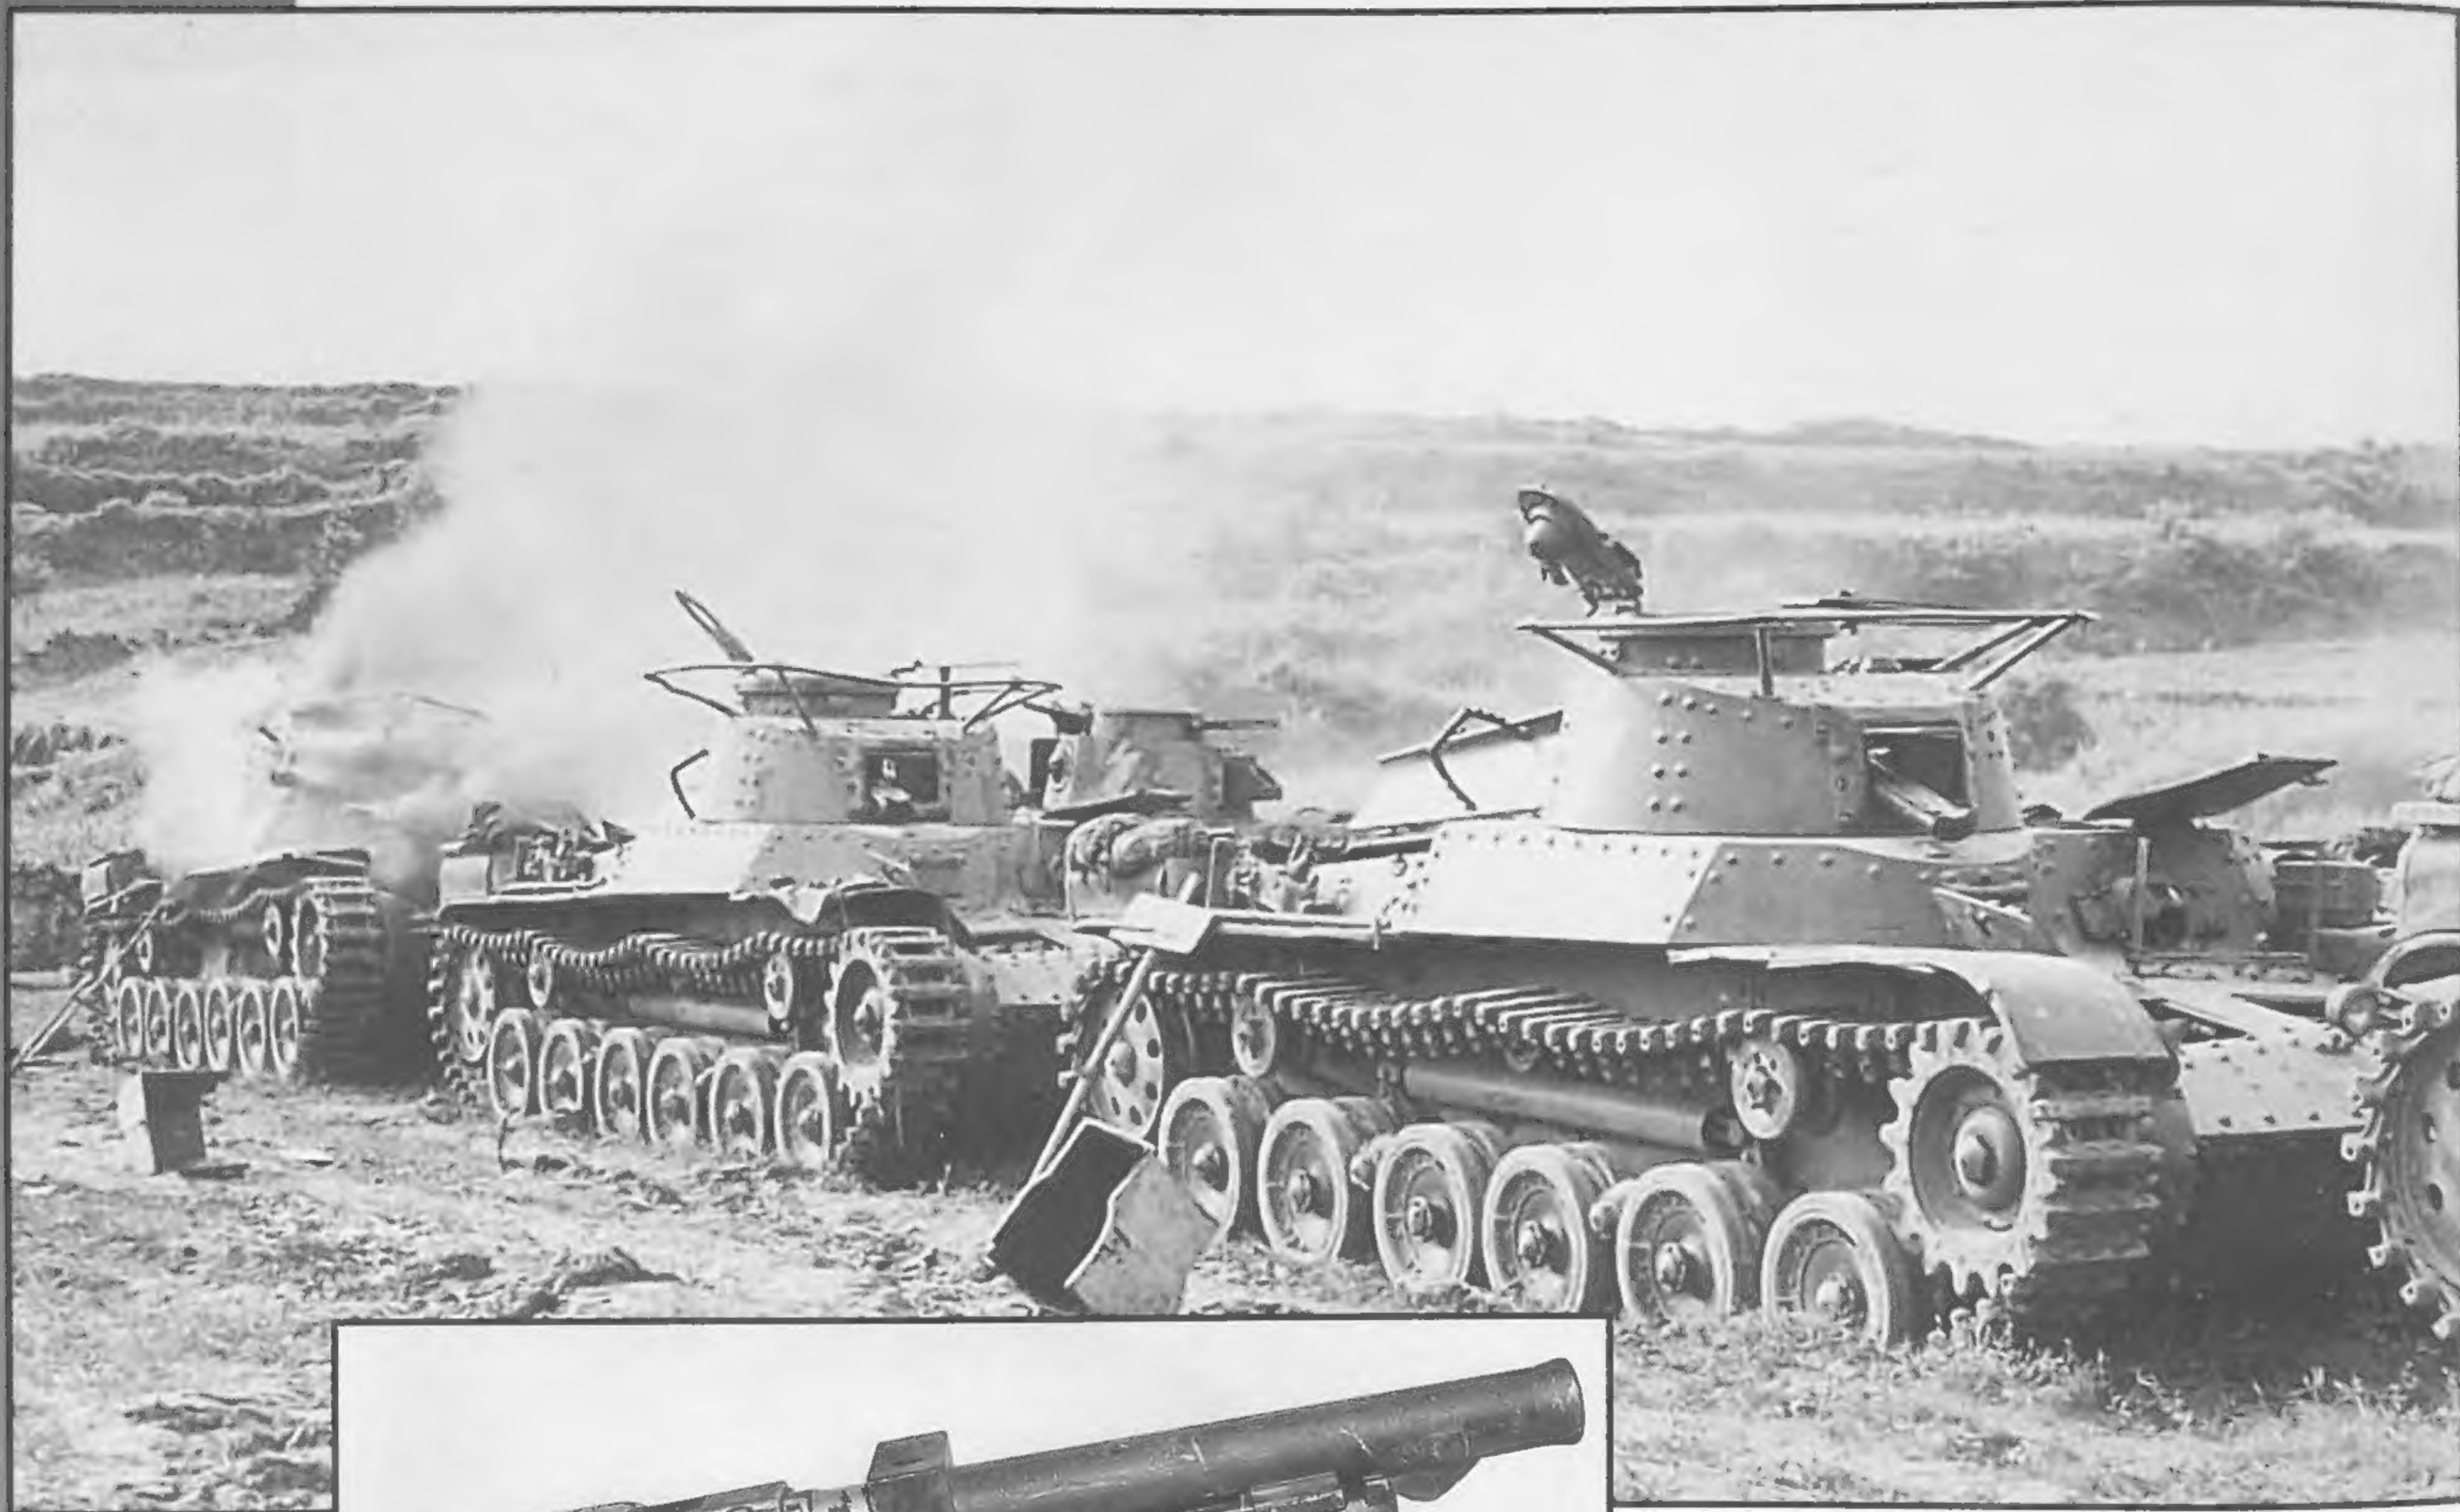
The Type 97 was produced from 1937 until late in the war with a total number produced of about 2,208, including the follow-up tank the Shinhoto. The main producer was Mitsubishi Jukogyo K.K., with some farming out of production to other smaller companies. The chassis for the Type 97 went on to be used in a variety of roles, including self-propelled guns and heavier tanks. Above: These Type 97s are being prepared for destruction after the war on Saishu Island, Japan on 1 October 1945.

**Above:** Another photo of the Type 97's being destroyed on Saishu Island. There is also a Type 95 'Ha-Go' Light tank in the background with interesting turret markings. **Left:** The Type 97 57mm main gun that goes into the Type 97 Medium Tank.

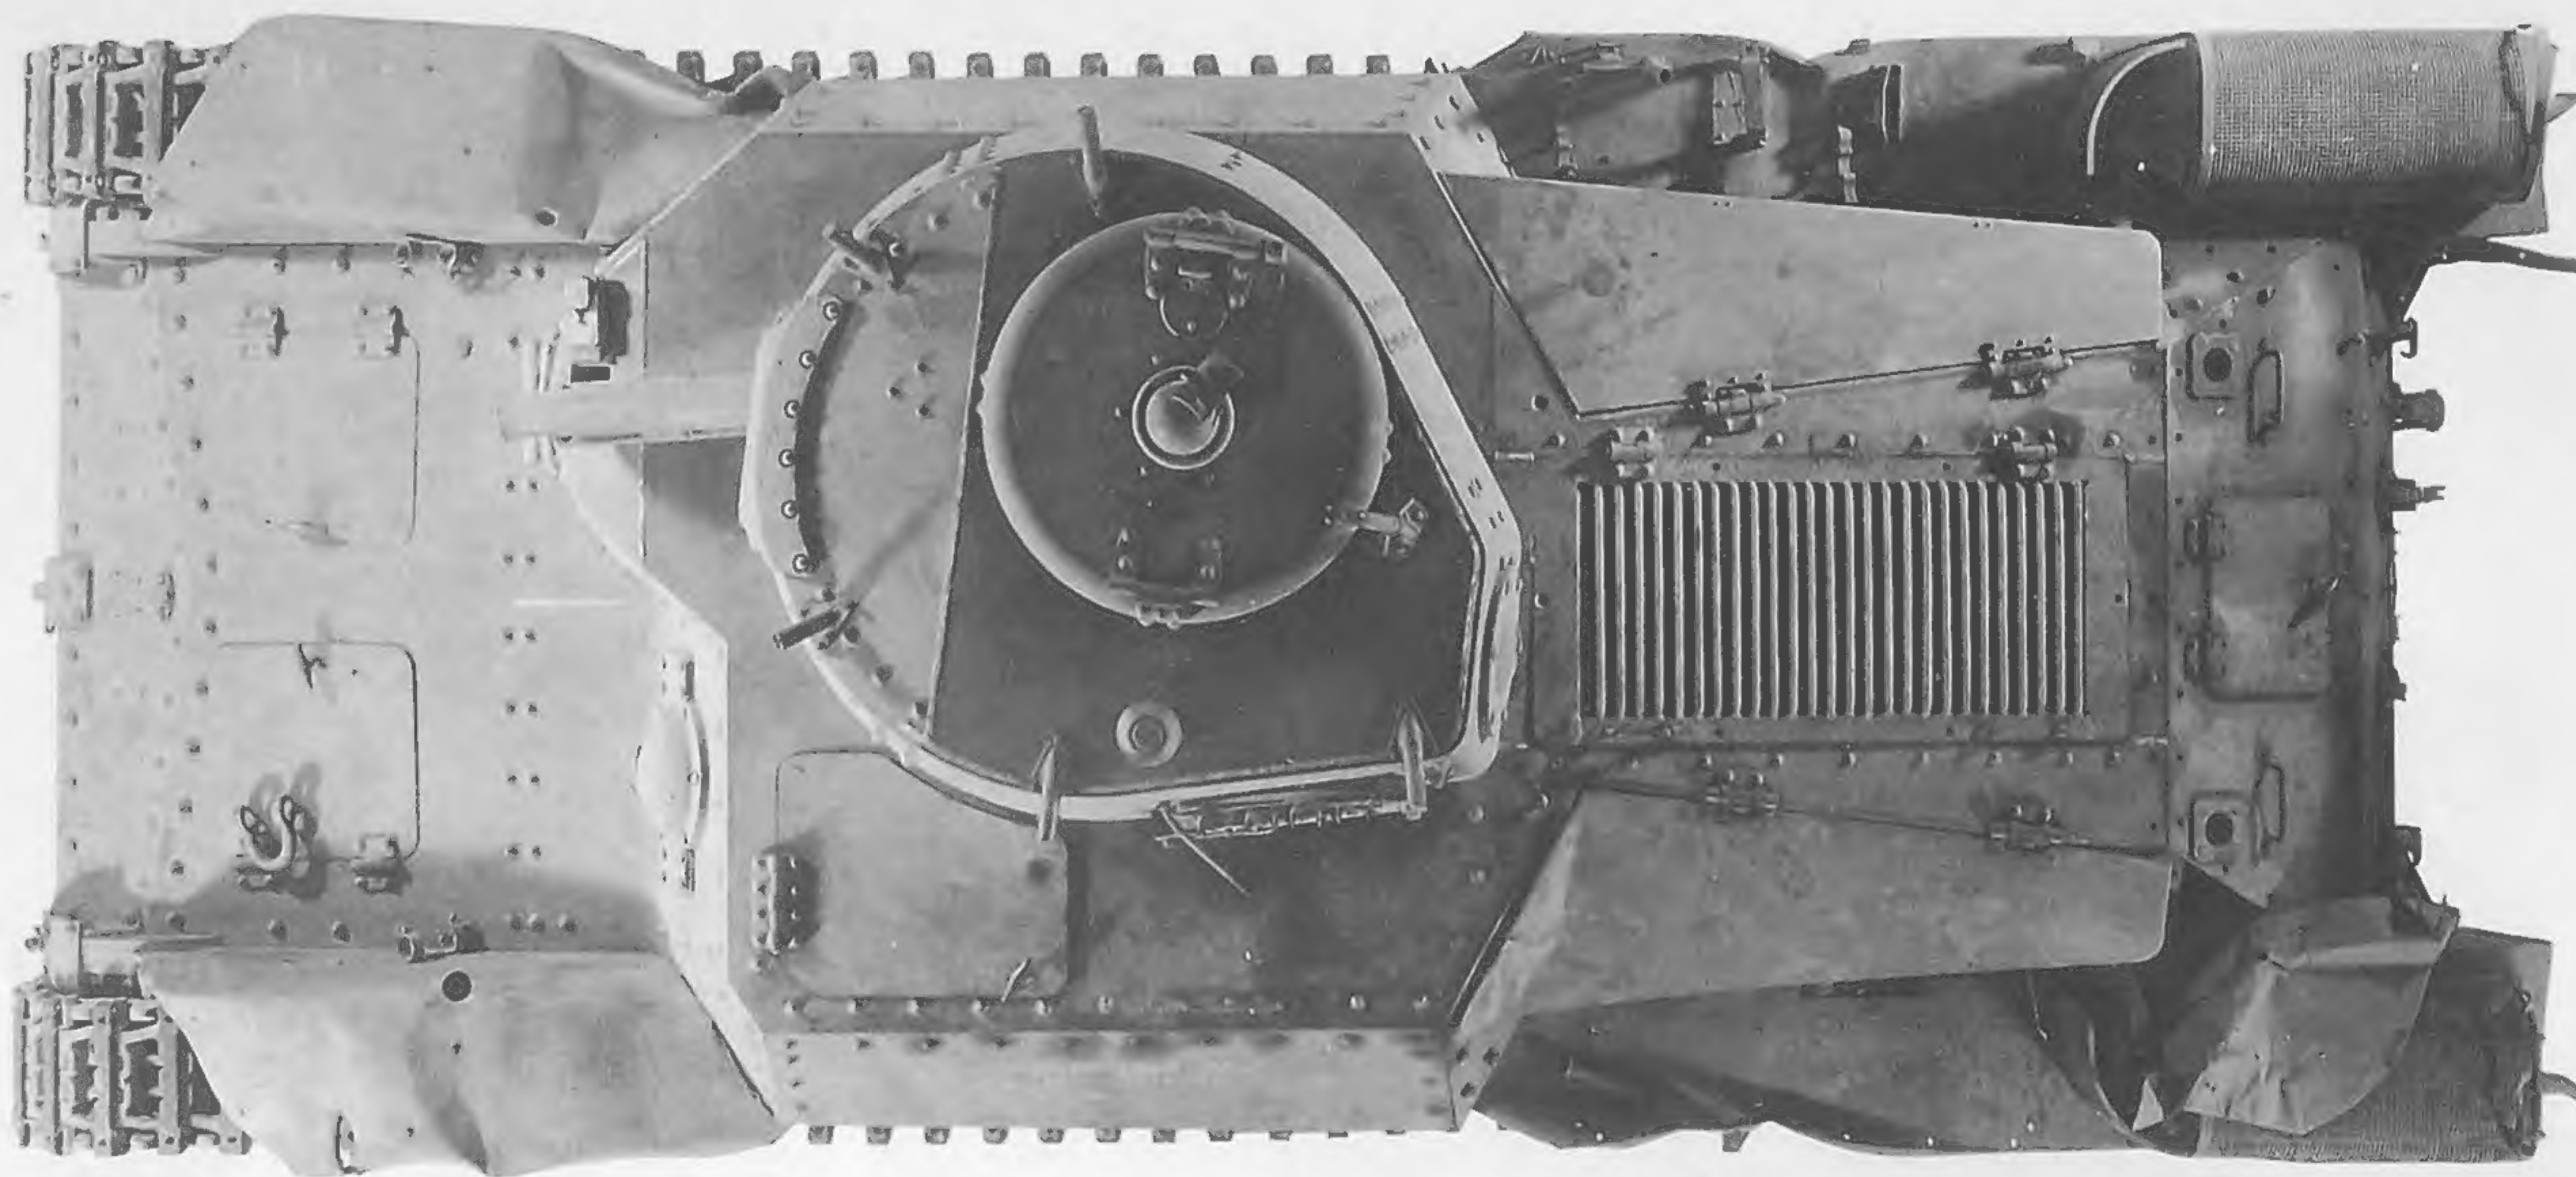
A top view of the previous Type 97. Notice the hole in the forward left fender. This is for the temporary antenna, which was usually associated with command tanks.
